Manhole Inspection Summary

Manhole # S17GG2001MH

Insp Date: **10/9/06 1:52 PM**

Location Address: **5900 SMITH AVE**

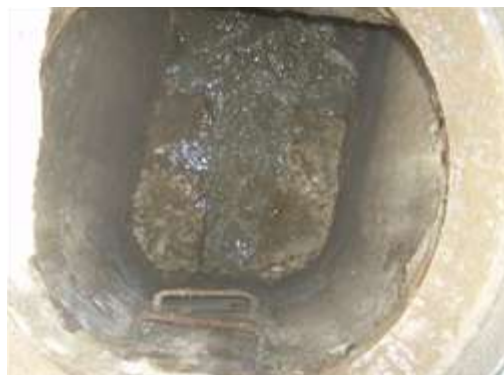
Top View

☒ **Debris** (not Condition related)

☒ **Corroded**

Corroded steps. Bench debris.

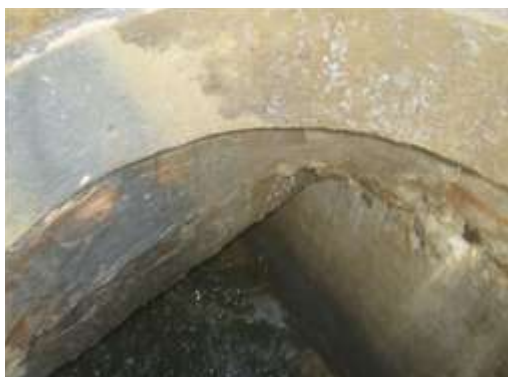
Defect

☒ **Leaks**

Infiltration: ☐ None ☒ **Joint** ☐ Cracks ☐ Mortar ☐ Roots ☐ Wall

Frame leaks. Adjustment infiltration.
